Stormwater Infrastructure Assessment Bay Point, California

Prepared for:
The Watershed Project

October 31, 2017

© 2017 Balance Hydrologics, Inc.
Project Assignment: 210135

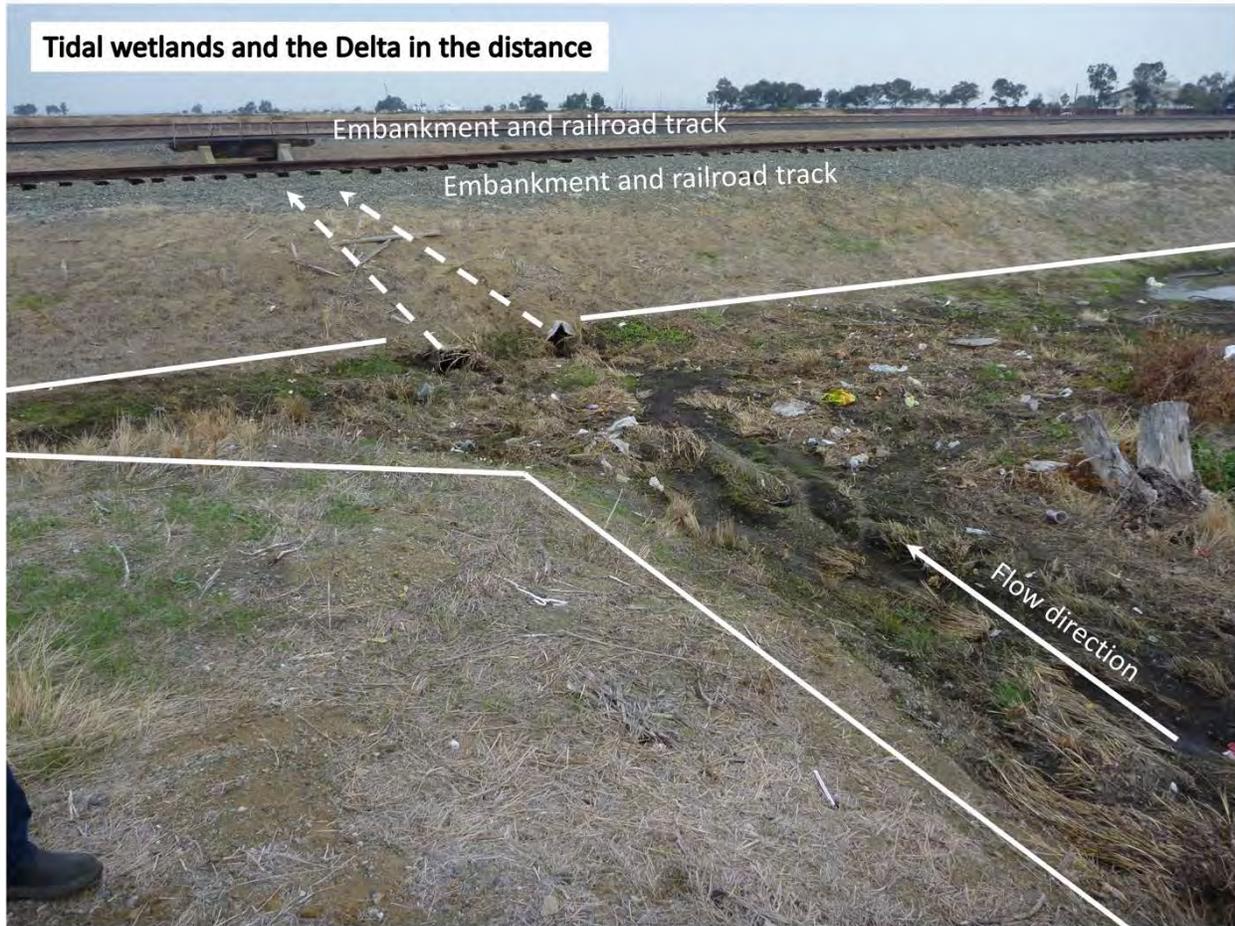
Figure 2-10 Railway embankments act as drainage barriers between developed lowlands in Bay Point and tidal wetlands.

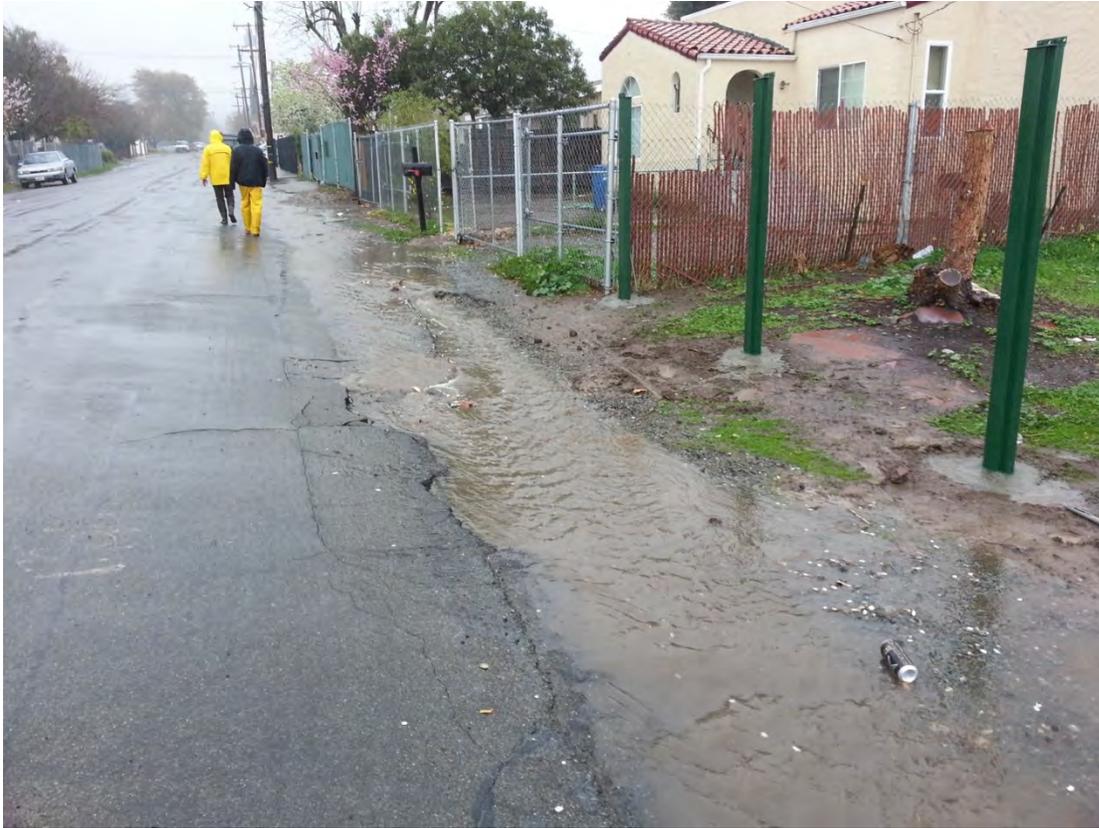
flow. Trash can be seen along the flow path, which can be conveyed to downstream depositional areas (such as in Figure 2-10) and eventually to the Delta if not diverted by a trash rack.

Figure 2-11 Urban runoff conditions at the north end of Bella Vista Avenue near Willow Pass Road.

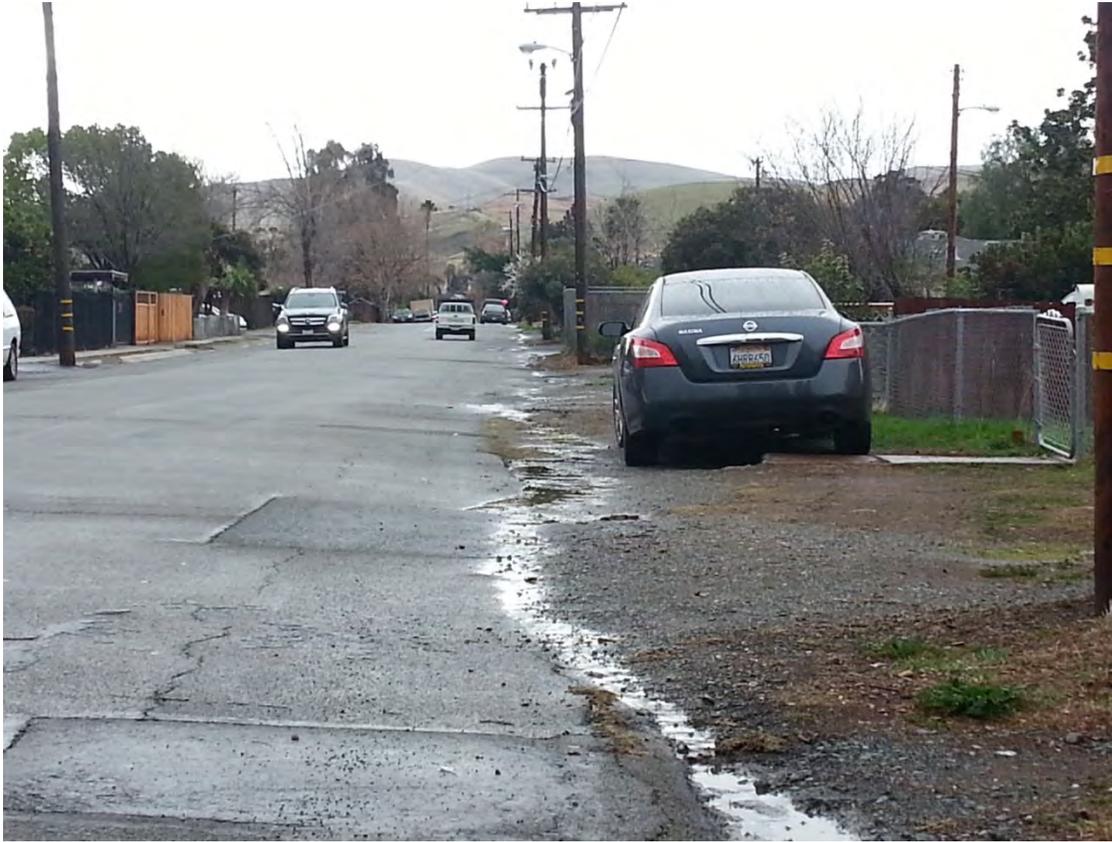
generated from rainfall onto locally impervious surfaces within the community rather than overflow from the channel.

Figure 2-12 Post-storm runoff and ponding along the west side of Bella Vista Avenue.

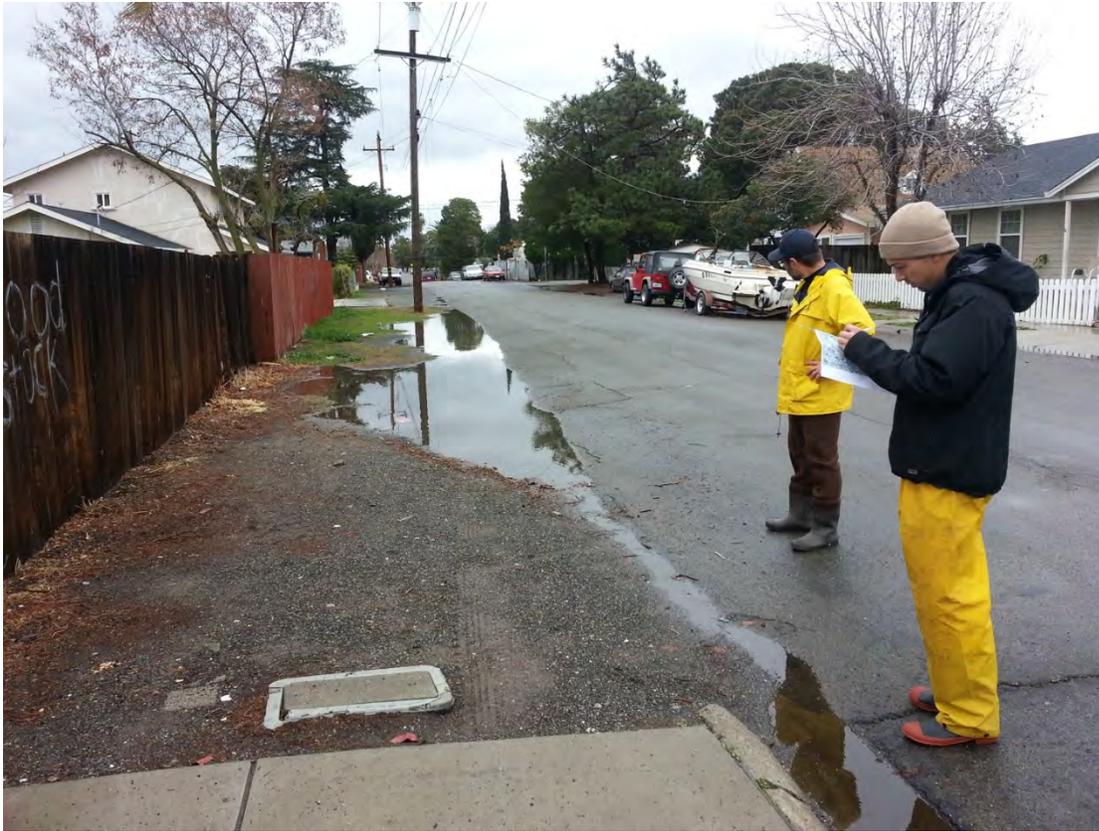
Figure 2-13 shows similarly discontinuous curbing and intermittent sidewalks along the north side of Hanlon Way, east of Bella Vista Avenue. Standing water highlights the flat, low-slope drainage conditions, and lack of positive drainage in the street profile. As elsewhere, standing water creates potential conditions for mosquito breeding, as well as interfering with parking by creating muddy, flooded conditions for homeowners.

Figure 2-13 Runoff ponding along Hanlon Way, west of Bay View Avenue.

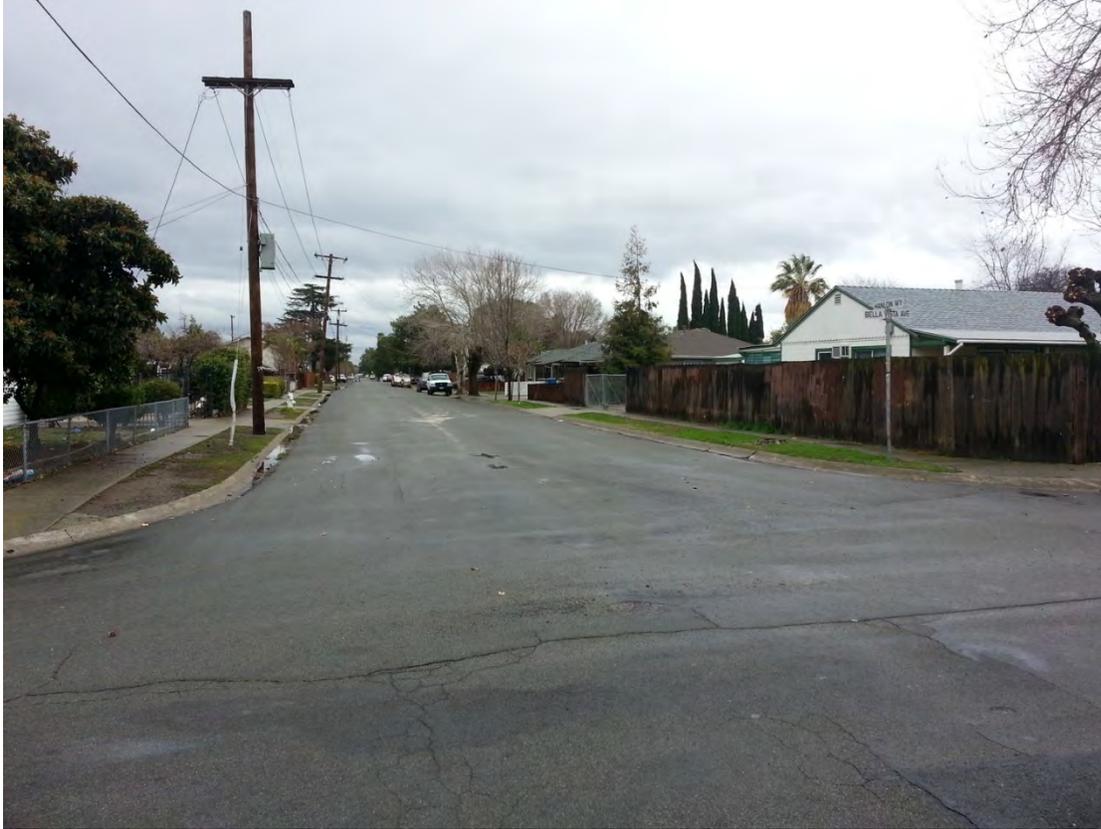
The drainage challenges in the prevailing terrain of older developments are further highlighted in Figure 2-14, which shows that residual standing water is encountered even where full curb and sidewalk have been constructed. Curbs prevent water from entering residential yards, though water is still accumulating in smaller quantities curbside, indicating ongoing drainage issues and lack of gutters to convey flows into a stormwater drainage system. No BMPs or LID features are present, though street widths appear to be large enough to be compatible with a “green street” type of retrofit.

Figure 2-14 Intersection of Hanlon Way and Bella Vista Avenue looking east.

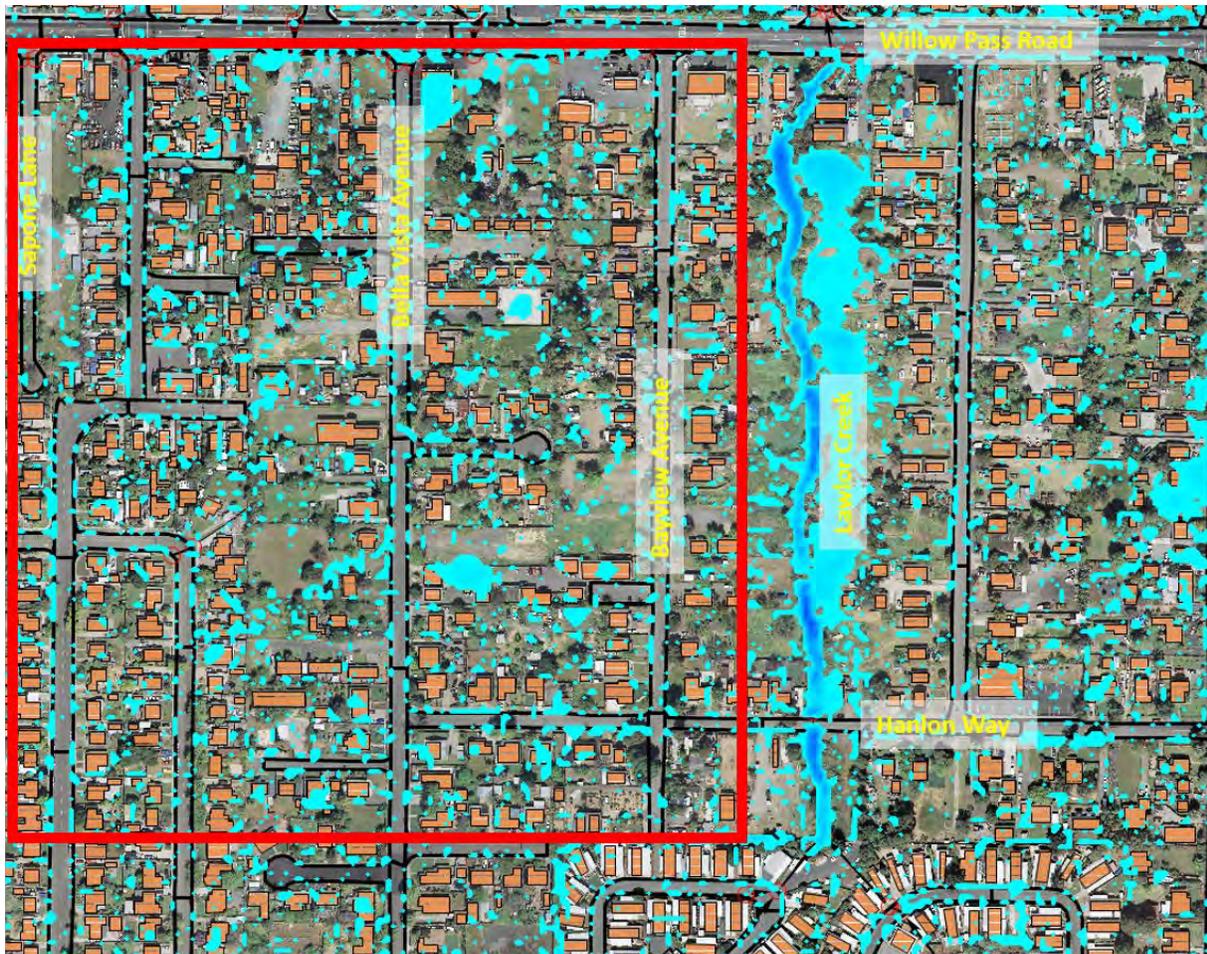
including numerous areas where roadside flow paths are deep enough to spread into adjacent yards and, in some cases, flow through private property.¹⁸

Figure 6-2 Existing conditions flood depths greater than 0.1 feet for the 2-year design storm in WCE. Red inset rectangle bounds the representative 52.2-acre area used for results and discussion related to LID facilities.

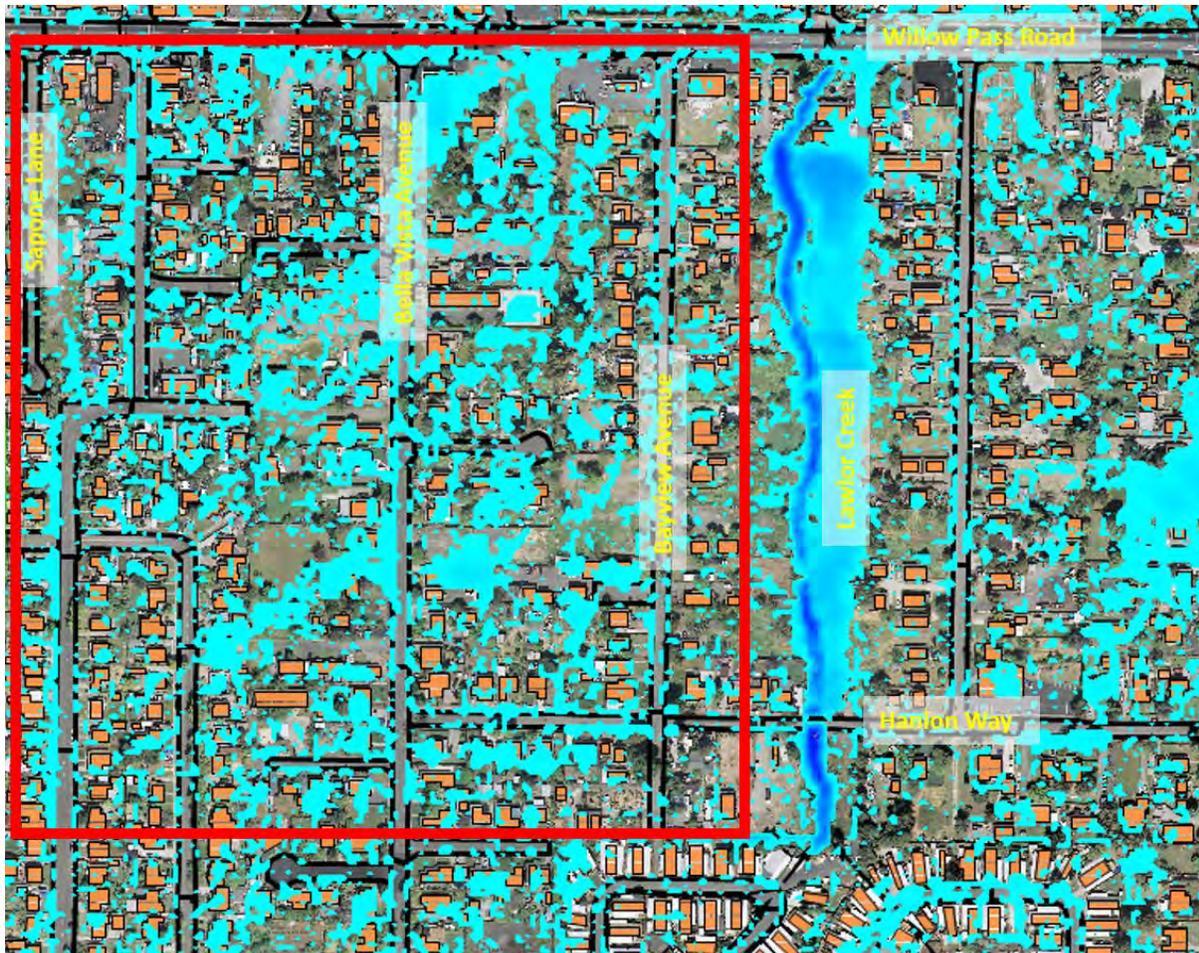
events. The northeast-trending swathes of blue on either side of Bella Vista Avenue represent locations where runoff will tend to leave the streets and flow downslope across private lots. Modern sub-division standards would typically require a safe release confined to public rights-of-way for runoff from storms up to the 100-year event, and this is clearly not what is predicted for the WCE Study Area. In fact, simple visual examination of the 2-D results readily shows where LID features could contribute most to alleviating localized flooding.

Figure 6-3 Existing conditions flood depths greater than 0.1 feet for the 100-year design storm in WCE. Note particularly the northeast trending overland flow paths east and west of Bella Vista Avenue.

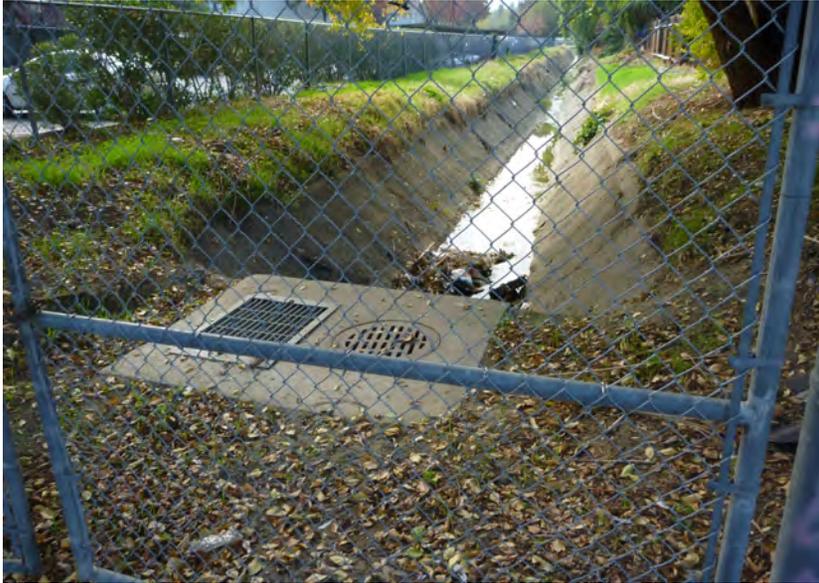
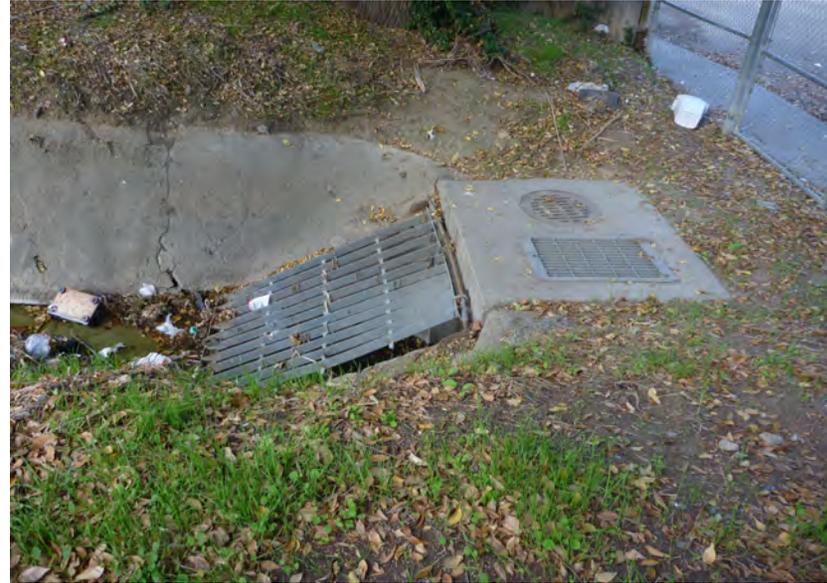
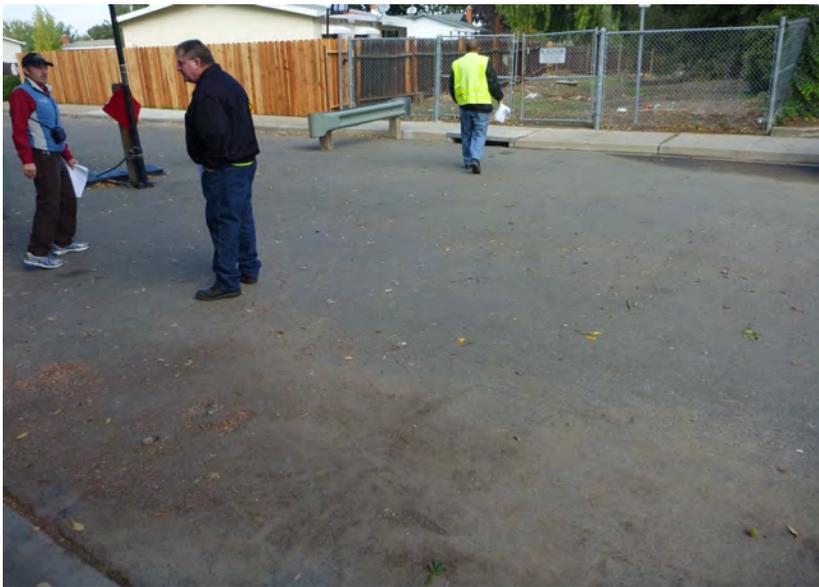
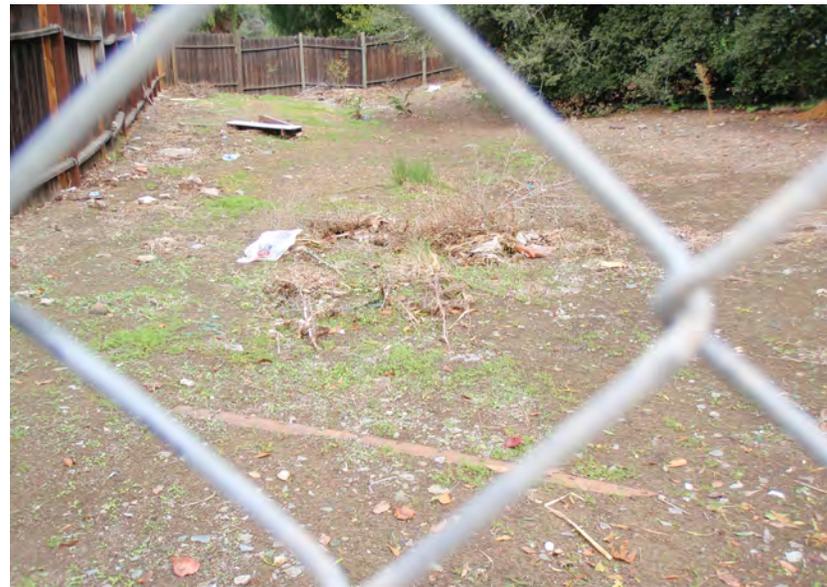
Figure 2. Mary Ann Lane east of Clearland Circle, Bay Point, California. Photos looking upstream at trapezoidal concrete channel, at trash rack, downstream toward road that commonly floods, and trash on downstream property that receives high flows.

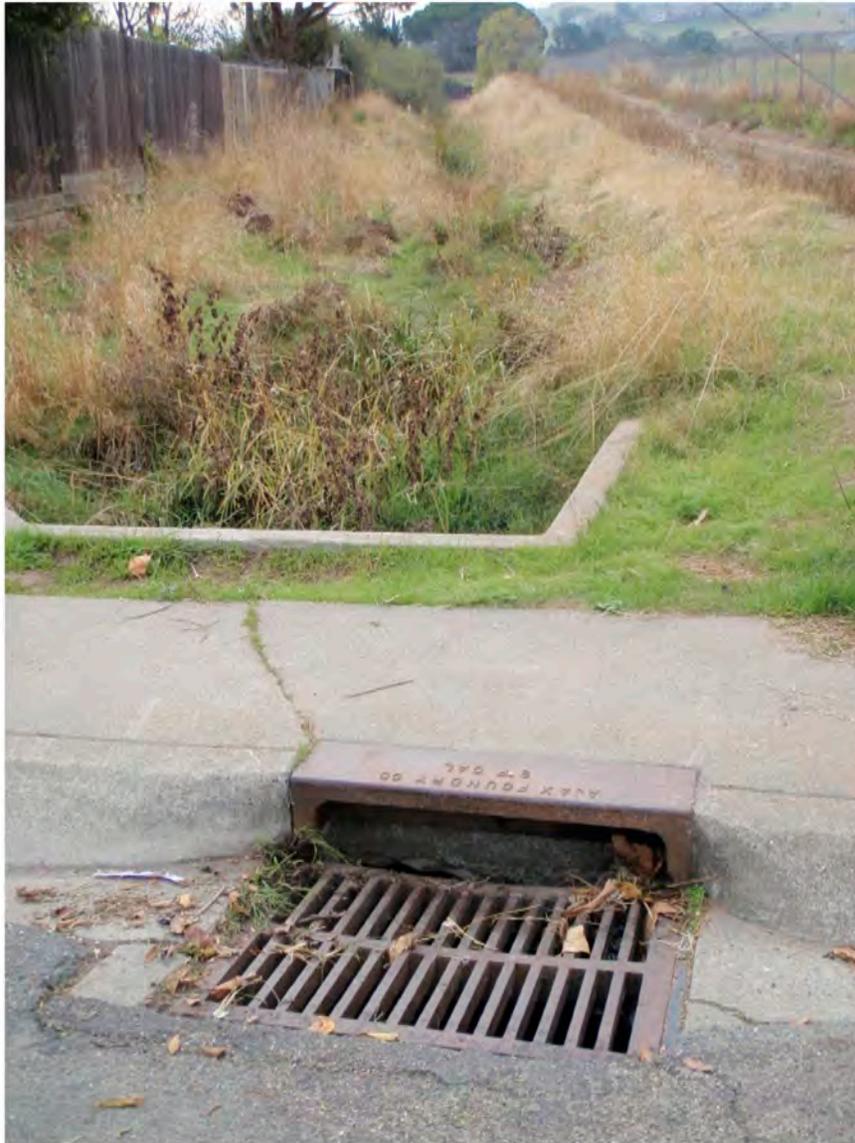
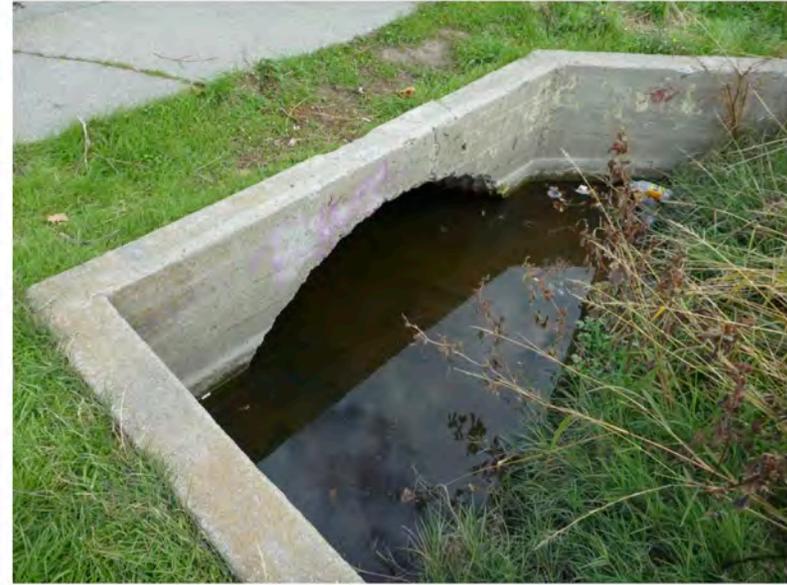
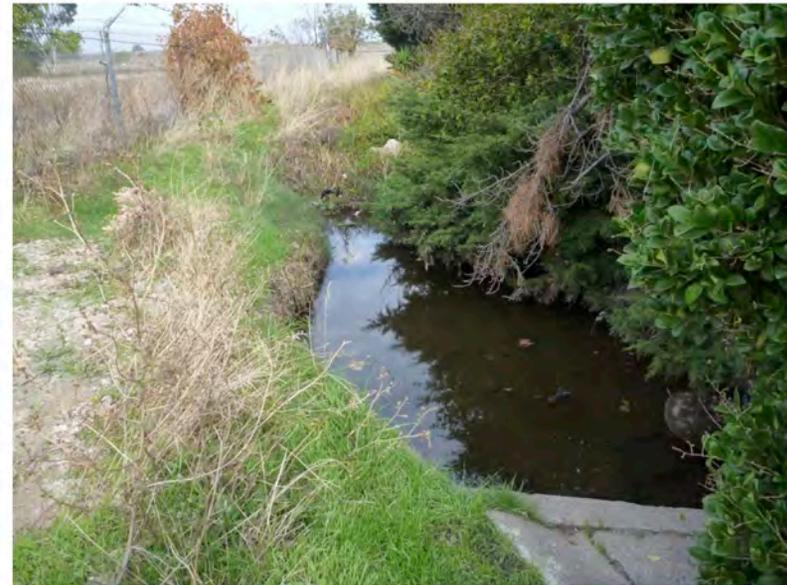
Figure 3. Shore Road west of Wharf Drive, Bay Point, California. Photos looking upstream at grate inlet and vegetated earthen channel, at upstream culvert inlet with standing water, and at downstream end of culvert toward train tracks.
