Stormwater Infrastructure Assessment Bay Point, California

Prepared for:
The Watershed Project

October 31, 2017

© 2017 Balance Hydrologics, Inc.
Project Assignment: 210135

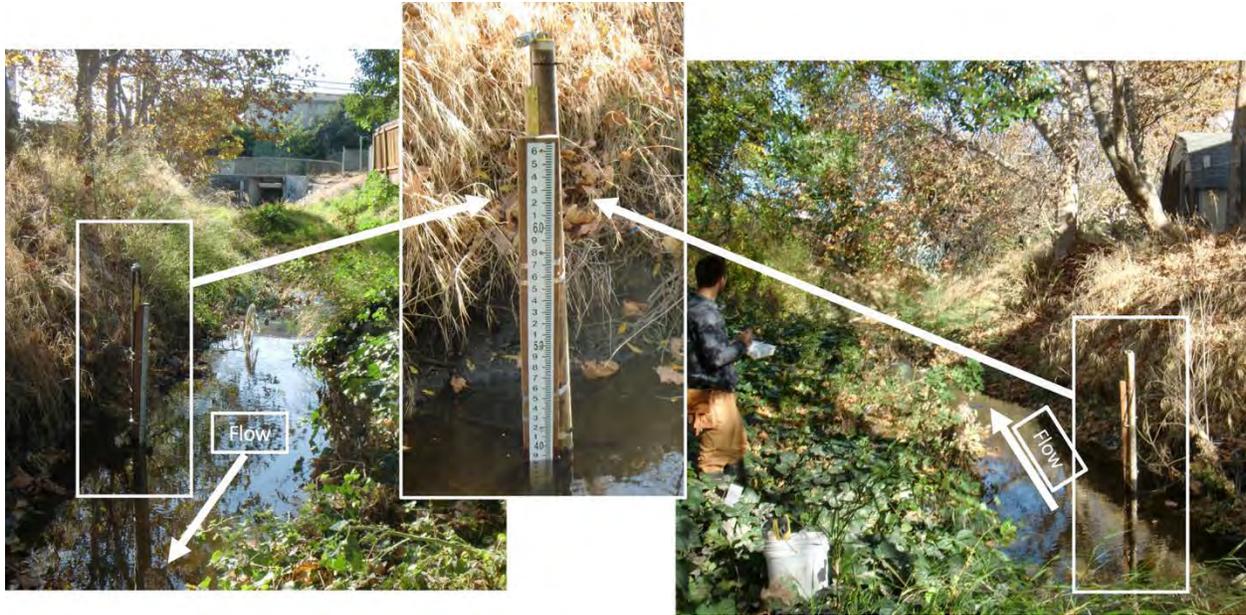
Figure 4-1 Streamflow equipment installed at Pacifica Avenue monitoring site in the Willow Creek Central sub-watershed.

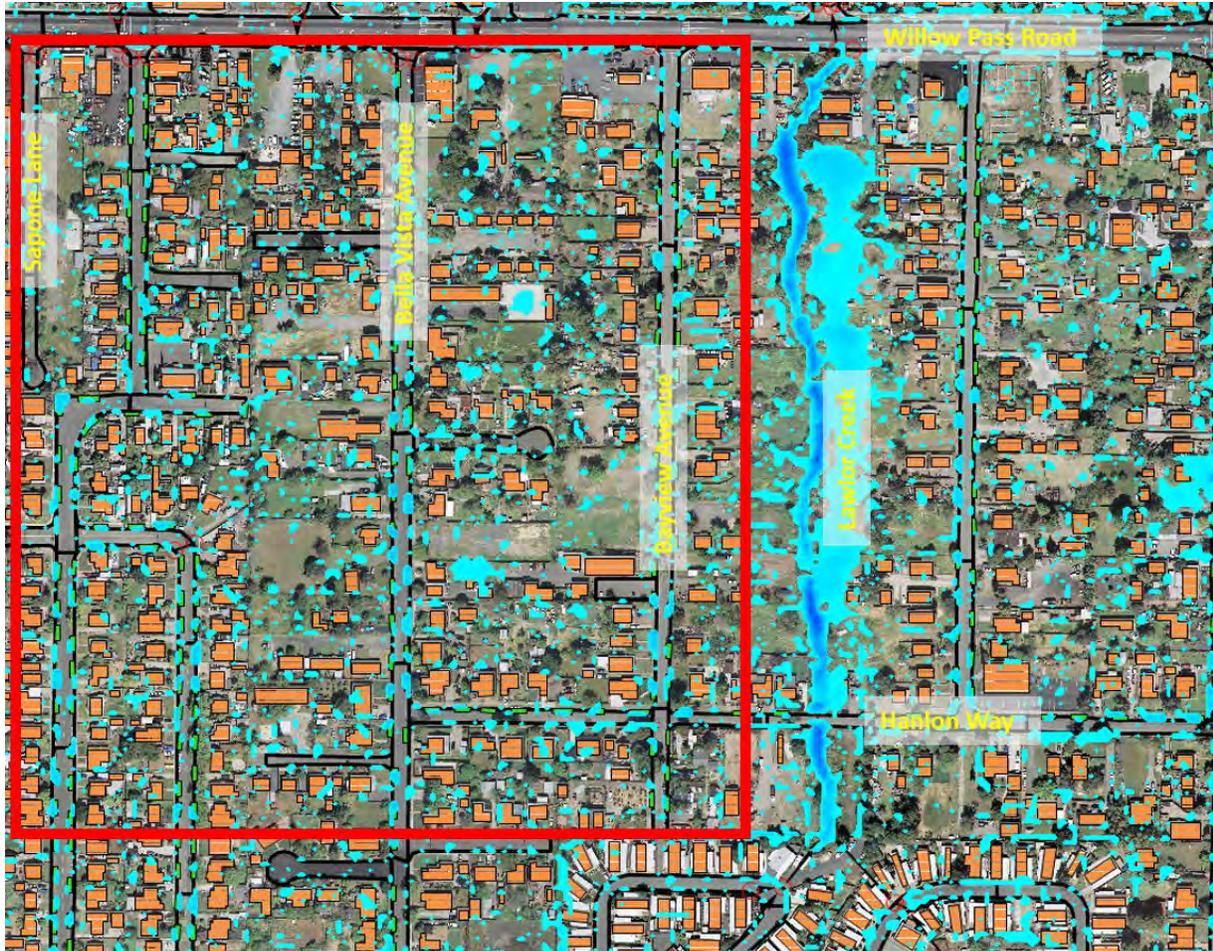
Figure 6-4 Flood depths greater than 0.1 feet for the 2-year design storm in the WCE Study Area with “rain garden” LID facilities. Total inundated acreage within the red-bounded representative area is 5.9 acres, down substantially from 8.4 acres under existing conditions.

The results in Table 6-4 focus on reductions in localized flooding greater than 3 inches in depth as a possible important threshold defining the transition from nuisance to damaging. Even though the LID features were rather uniformly placed for the demonstration modeling and not connected to additional storm drain infrastructure (catch basins, pipes, etc.), the results show that the extent of deeper flooding can be reduced by almost half across a wide range of design storm sizes.

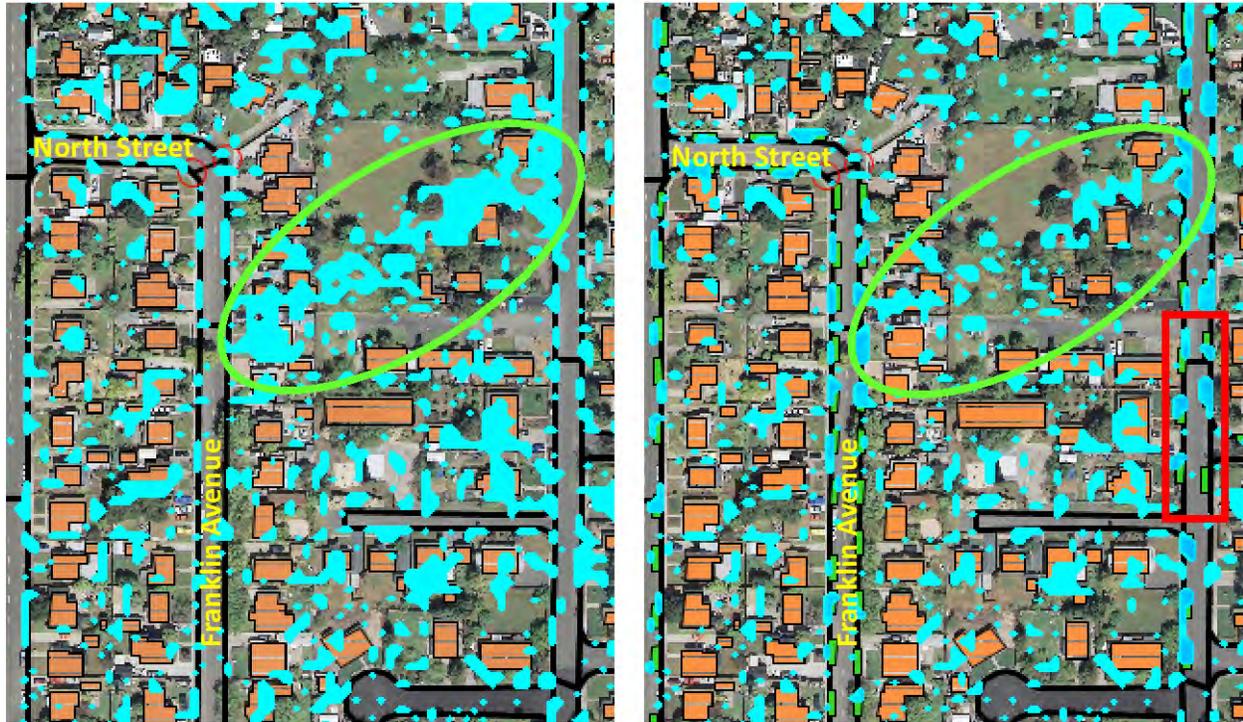
A good example of relatively uniform inundation of the modeled rain gardens can be identified along Franklin Avenue, a north-south street in the southwest portion of the representative area. Review of the existing conditions model output showed that runoff along the east side of the street has a tendency to break-out and flow overland across private property toward Bella Vista Avenue (Figure 6-3). The LID modeling, therefore, included a relatively high density of rain garden installations along Franklin to investigate whether rain gardens could be used to address this issue. Results are illustrated in Figure 6-5 for the case of the 10-year design storm. The contrasting views of existing conditions (left) and that with LID features (right) show the overall reduction in localized flooding and specifically underscores the potential for reducing flow break-outs into adjacent yards.

Figure 6-5 Flood depths greater than 0.1 feet for the 10-year design storm in the vicinity of Franklin Avenue under existing conditions (left) and with LID facilities (right). The area highlighted with the oval shows the potential marked reduction in overland flow across private property from the break-out east from Franklin roughly 200 feet south of North Street. LID rain gardens are difficult to identify; six units are located in the rectangle in the right panel with five of six partially or fully inundated.

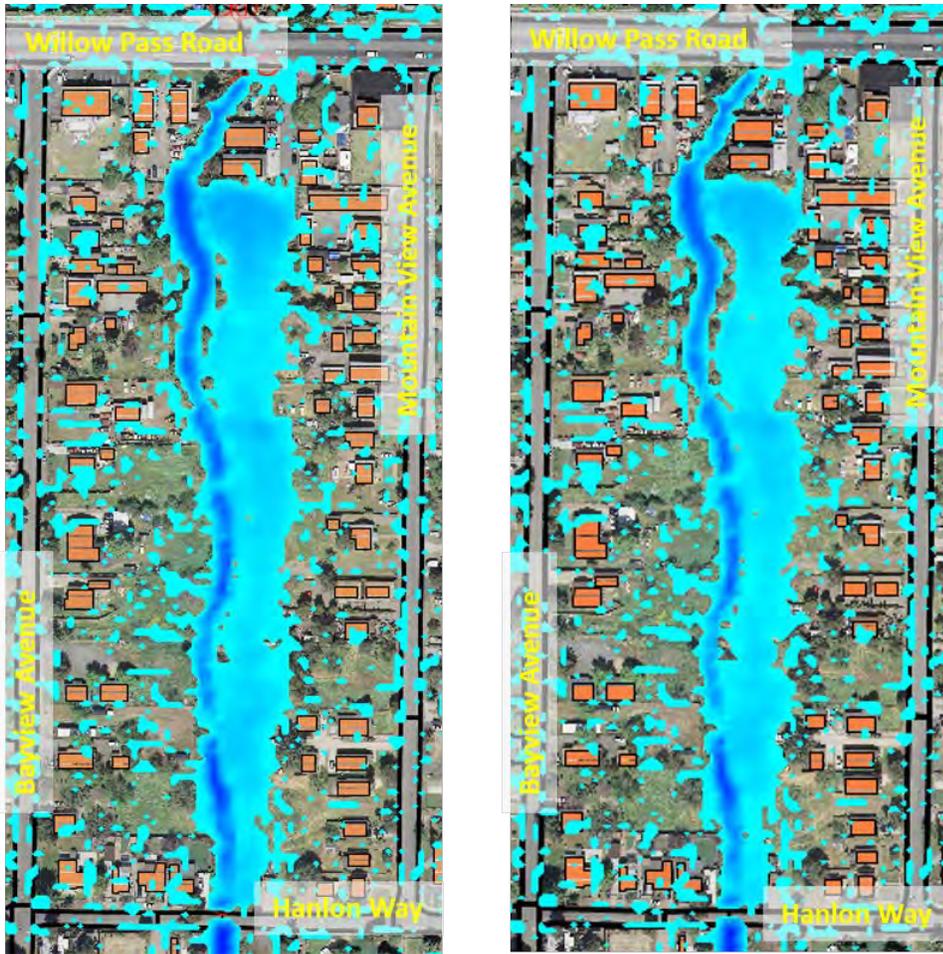
Figure 6-6 Flood depths greater than 0.1 feet for the 10-year design storm along Lawlor Creek under existing conditions (left) and with a coordinated vegetation management program.

The predicted extents of creek flooding as shown in Figure 6-6 are not dramatically different, though close inspection does reveal less encroachment to existing structures, particularly on the east (right bank) of the creek (right side of the creek in each figure). However, the gridded output data from the 2-D model platform allows for detailed statistical analysis of the results in terms of flood elevations, flood depths, and other related parameters. Figure 6-7 shows an example with respect to flood depth reduction for this case, noting that flood depth is an important factor in the amount of potential flood damage and in setting structure elevations to avoid flood risk.

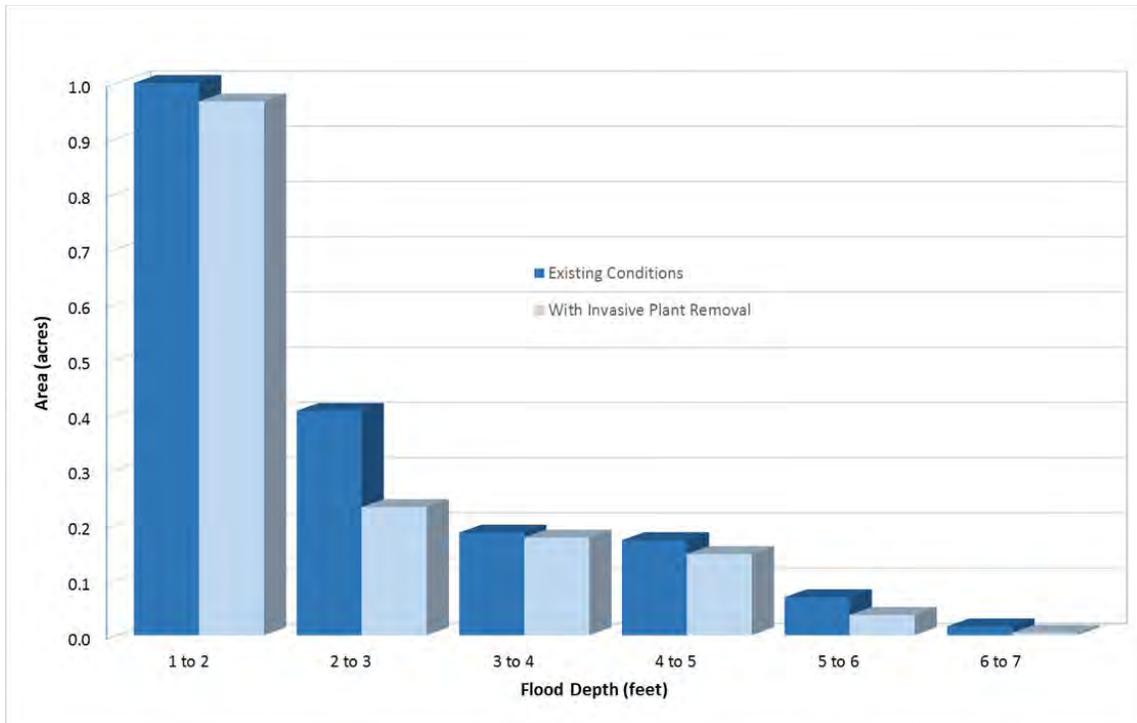
Figure 6-7 Flood depth distribution along Lawlor Creek between Hanlon Way and Willow Pass Road under existing conditions and with invasive plant removal. Note the general reduction in flood depths and the significant drop in area flooded between 2 and 3 feet deep.

The modeling results show that removal of invasive species in a coordinated manner could substantially reduce flood depths along the creek. Flood depth reductions of 6 inches or more would be expected for 0.7 acres of the floodplain, and the total area flooded to 1-foot depth or more would be reduced from 2 acres to 1.6 acres, so at least some of the structures that currently are at risk from flooding during high flows would likely benefit from a maintenance program that included vegetation control between Hanlon Way and Willow Pass Road. Any efforts at further reduction in flood potential in this neighborhood might have to consider more substantial interventions than those offered by vegetation control.

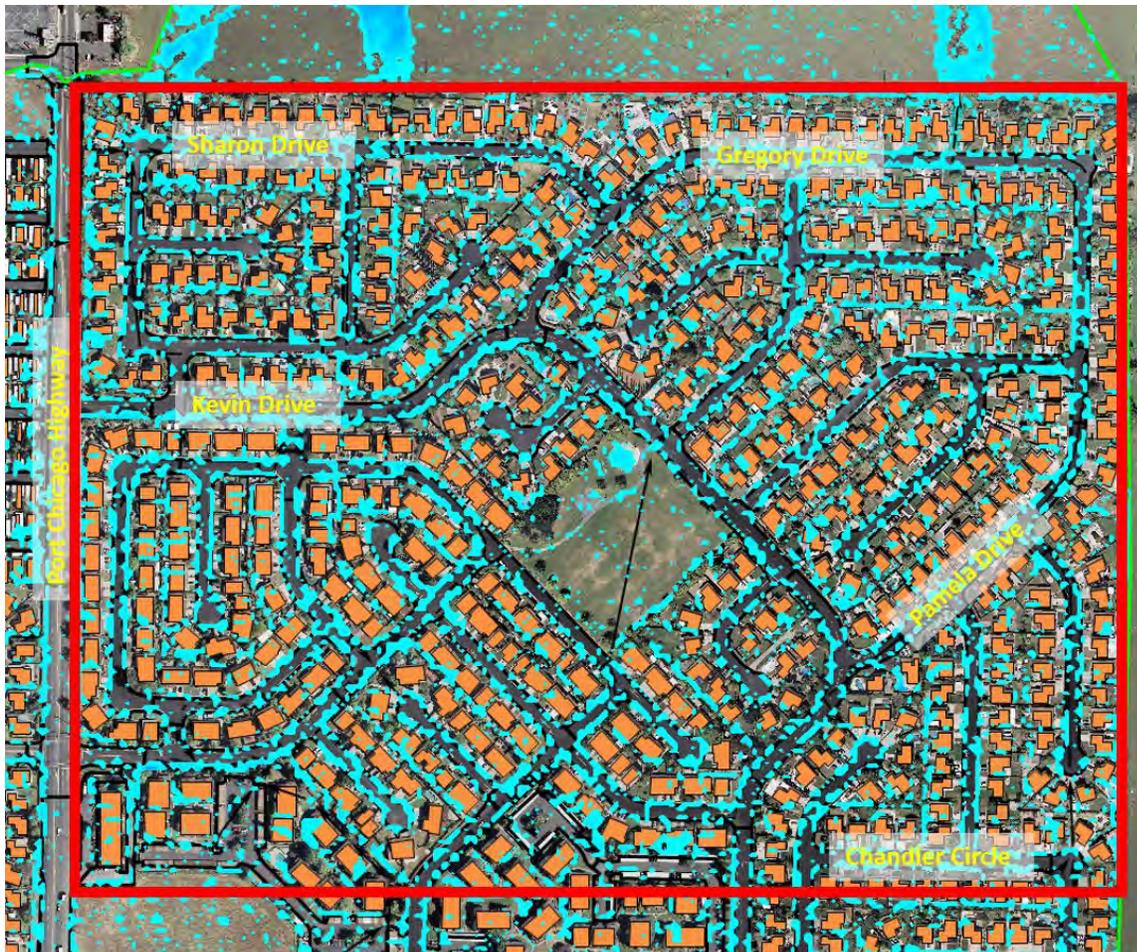
The tabular data confirm that the higher density and impermeable surfaces associated with the representative area leads to relatively large amounts of total area, from 22 to 31 percent, subject to localized flooding. However, Figure 6-8 shows that the model captures the fact that almost all of this flooding would be limited to the public right-of-way, as can be expected of a sub-division with raised lot elevations and continuous curblines (typically 6 inches high). These observations coupled with the existing extensive storm drain pipe system allows stormwater runoff to be largely confined to the streets for even the largest of the design storms, as evidenced by the relatively small increase in the percent of the total area predicted to flood to depths greater than 3 inches between the 2-year event (six percent) and the 200-year event (ten percent). This contrasts with the WCE Study Area where the same predicted depths ranged from two to eight percent (Table 6-3), noting that much more of that flooding was off-street.

Figure 6-8 Flood depths greater than 0.1 feet for the 2-year design storm in the WCC Study Area under existing conditions. The red inset rectangle bounds the representative 119-acre area used for results and discussion.

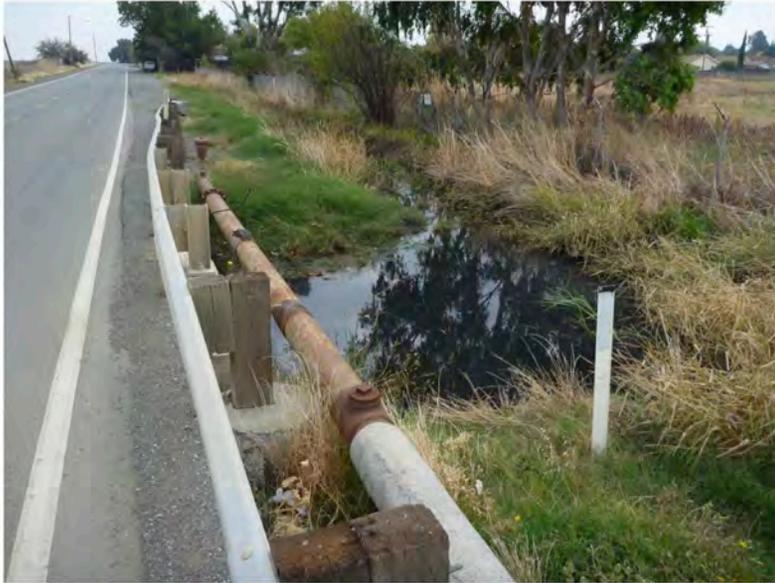
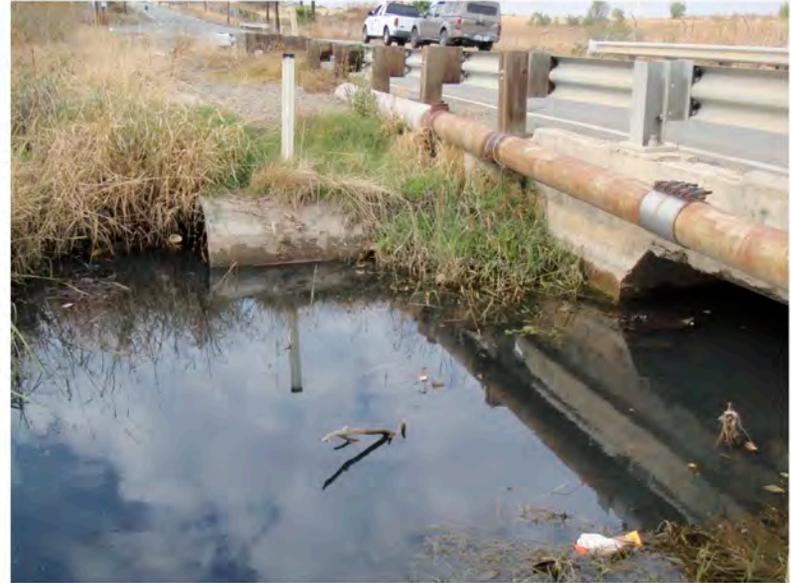
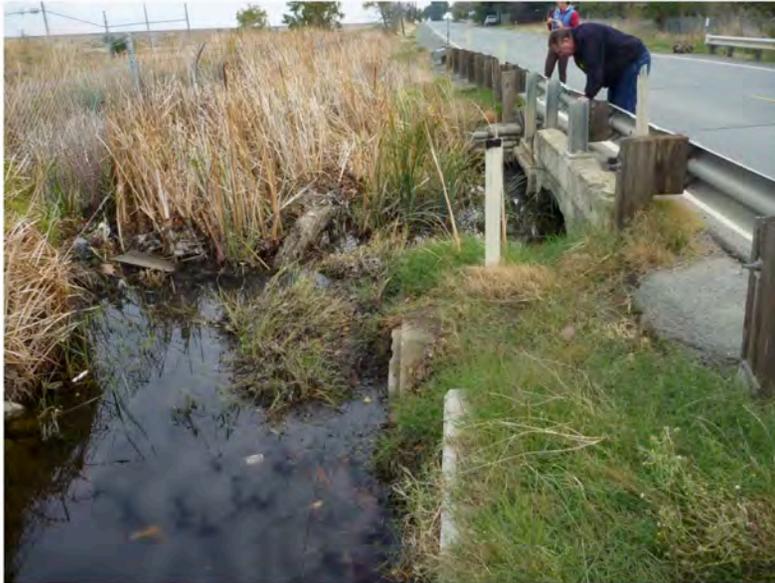
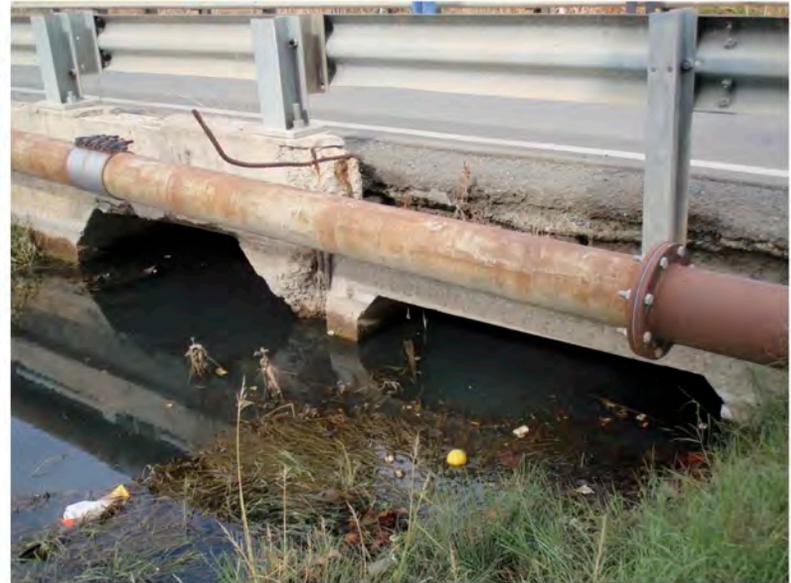
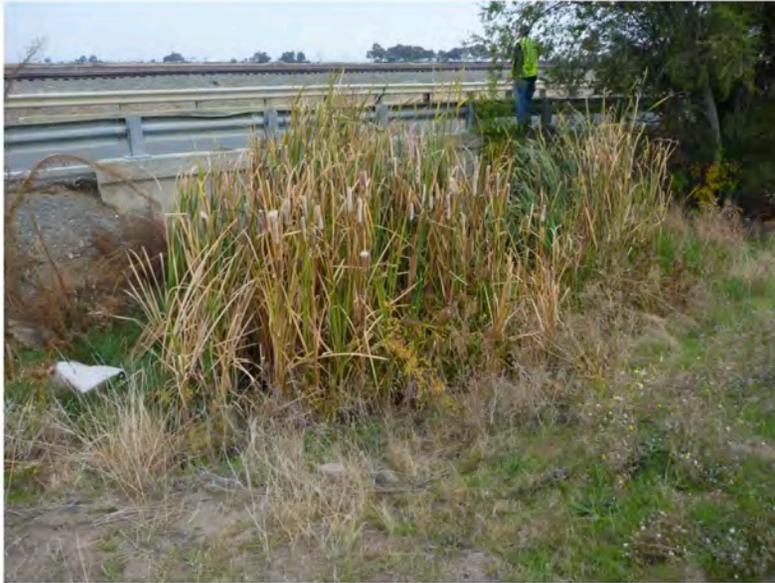
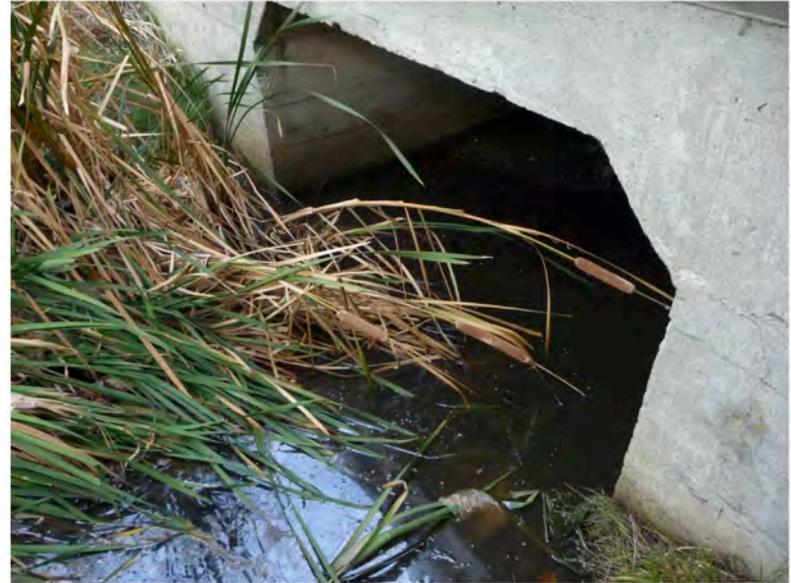
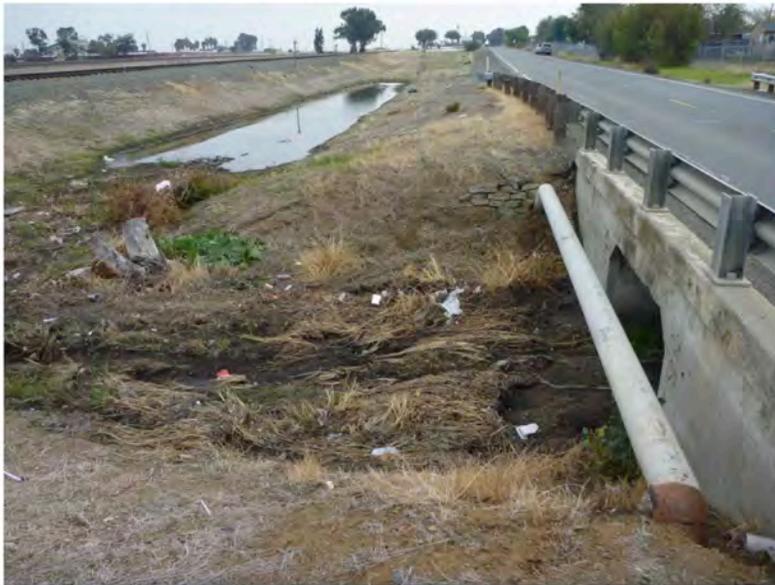
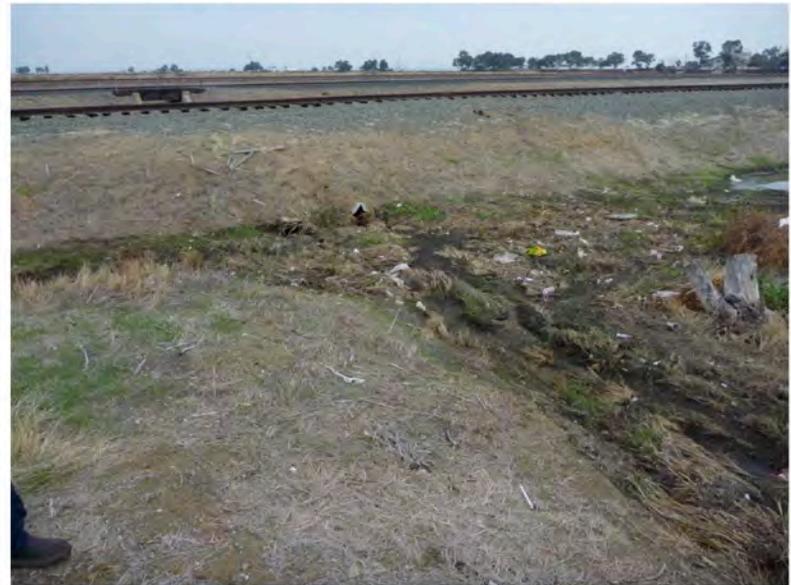
The next location, on Shore Road west of Wharf Drive (**Figure 3**), consisted of an earthen channel that conveys flows into a culvert to pass under Shore Road and then outfalls downstream north of Shore Road into a smaller earthen channel. Standing water was observed upstream and downstream of the culvert. Standing water suggests limited conveyance capacity of the channel and culvert, which are likely because of flat channel bed slope conditions, as well as flow obstructions, including stands of vegetation growing in the channels, and trash, including concrete debris. The portion of adjacent land to the west of the channel and at a similar low elevation is not developed and likely serves as an overflow detention zone during high flows.

Figure 3. Shore Road west of Wharf Drive, Bay Point, California. Photos looking upstream at grate inlet and vegetated earthen channel, at upstream culvert inlet with standing water, and at downstream end of culvert toward train tracks.
